# Haskill Creek – Reimer Reach Floodplain Renovation

DEQ 319 Grant Contract 211083

**Project Title: Haskill Creek - Reimer Reach Floodplain Renovation**

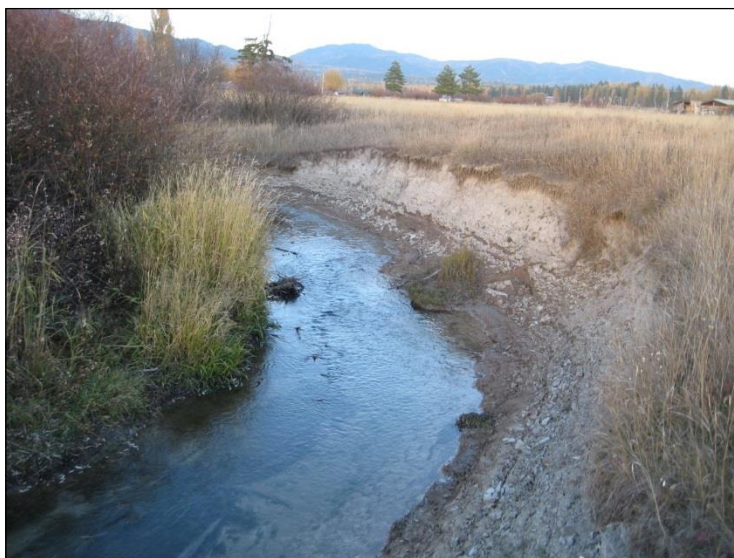
**Figure 2.** Photo showing the highly eroding streambank that characterized the site prior to the renovation. This photo shows Site 4 in 2008.

Reimer reach, had highly eroding streambanks and terraces with minimal or shallow-rooted grasses and forbs as riparian vegetation (Figure 2). The assessments recommended bank and floodplain restoration to reduce sediment inputs and re-establish connectivity between the channel and the floodplain. The Haskill Creek – Reimer Reach Floodplain Renovation project implemented these restoration treatments, including the lowering of high banks, installation of woody debris jams and conifer/willow fascines, and a rigorous revegetation of the floodplain, along this degraded stretch of Haskill Creek (Figure 3; Attachment R) to achieve the non-point source pollution reduction goals set in the original watershed assessment.

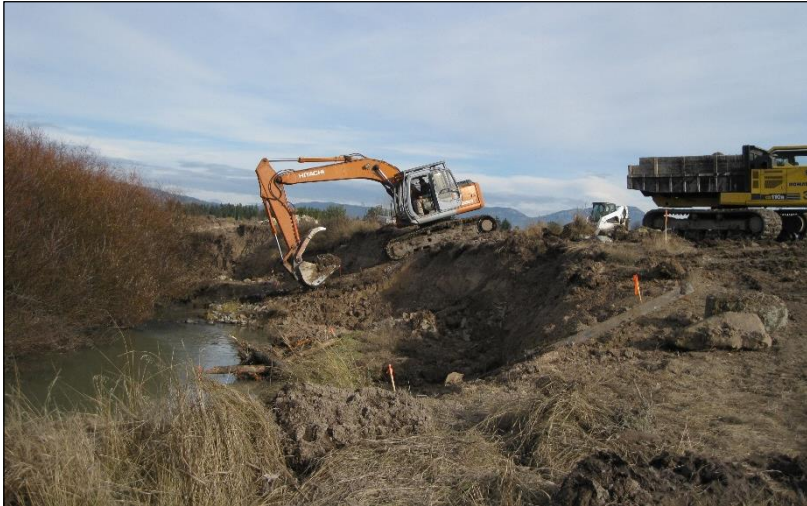
**Figure 4.** Construction activities during the Haskill Creek floodplain renovation; November, 2012.

The floodplain renovation demonstration project construction began on 10/15/12 and continued through November of 2012. The subcontractor, RDG, oversaw all construction and planting activities. RDG staked the project excavation limits and cut and fills using survey grade GPS. Their subcontractor, Glacier Excavating, Inc., performed all construction-related activities, which included the excavation of stream terraces to make new floodplain surfaces and the installation of bank restoration structures (e.g., toe wood along streambanks; Figure 4). RDG checked and certified the as-built elevations and assisted with the orientation and layout of the structures. Volunteers from Flathead Valley Trout Unlimited helped cut willow stems to plant along the streambank. Students from Whitefish High School's Project FREEFLOW (Flathead River Educational Effort for Focused Learning in Our Watershed) planted the containerized riparian vegetation (Figure 5). Members of the Montana Conservation Corps (MCC) also

helped plant containerized plants, and they installed weed mats and browse protectors (Figure 5). Construction for Site 5 differed from the other sites because it employed the DEQ-requested soil lift/willow hedge brush and conifer fascine technique instead of toe wood. Representatives from DEQ and FWP visited the site on 10/25/12 to oversee the installation of this technique by the subcontractors. In addition, members of MCC provided labor, volunteer management, and supervision for the harvesting of smaller willow stems for this site and

construction of the conifer fascine. Both Sites 2 and 5 were lengthened slightly to improve the results. Finally, the floodplain was seeded with a wetland plant seed mixture in December 2012. All the re-vegetation efforts were in accordance with NRCS riparian buffer guidelines, and efforts were made to prohibit sediment from entering the creek during construction. Photographs of the treatments for each site are provided in the final monitoring report prepared by RDG (Attachment I).

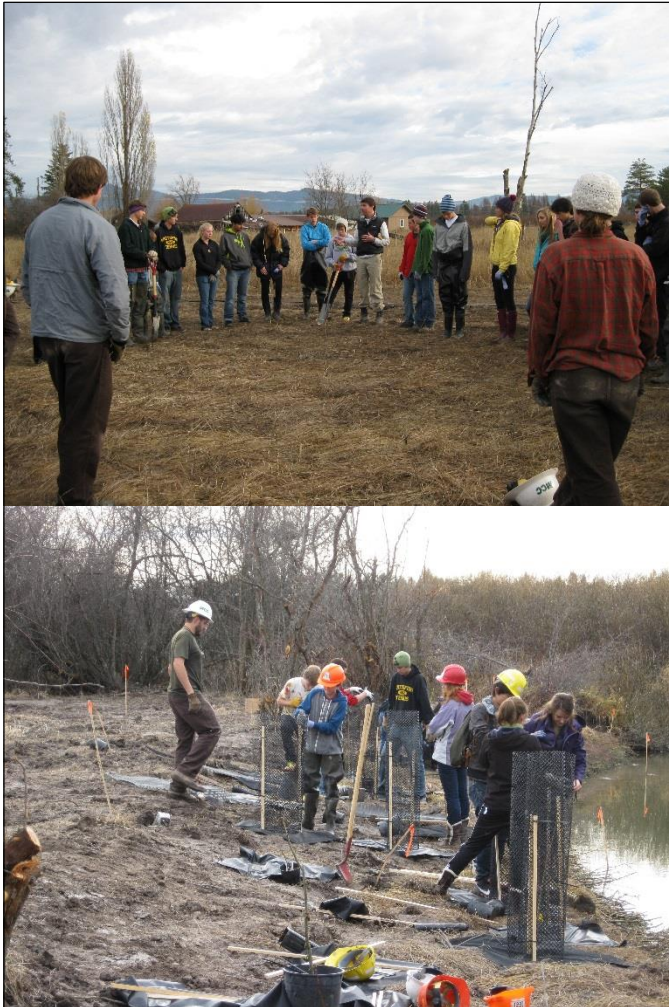
**Figure 5.** Students from Project FREEFLOW and members of MCC installed containerized vegetation in November, 2012. *Upper* – John Muhlfeld of RDG (subcontractor) discusses floodplain dynamics with volunteers. *Lower* – FREEFLOW students working with MCC members.
